# Flightfax

ARMY AVIATION  
RISK-MANAGEMENT  
INFORMATION

OCTOBER 2004 ♦ VOL 32 ♦ NO 10

## WHAT CREW CHIEFS REALLY WANT AND NEED

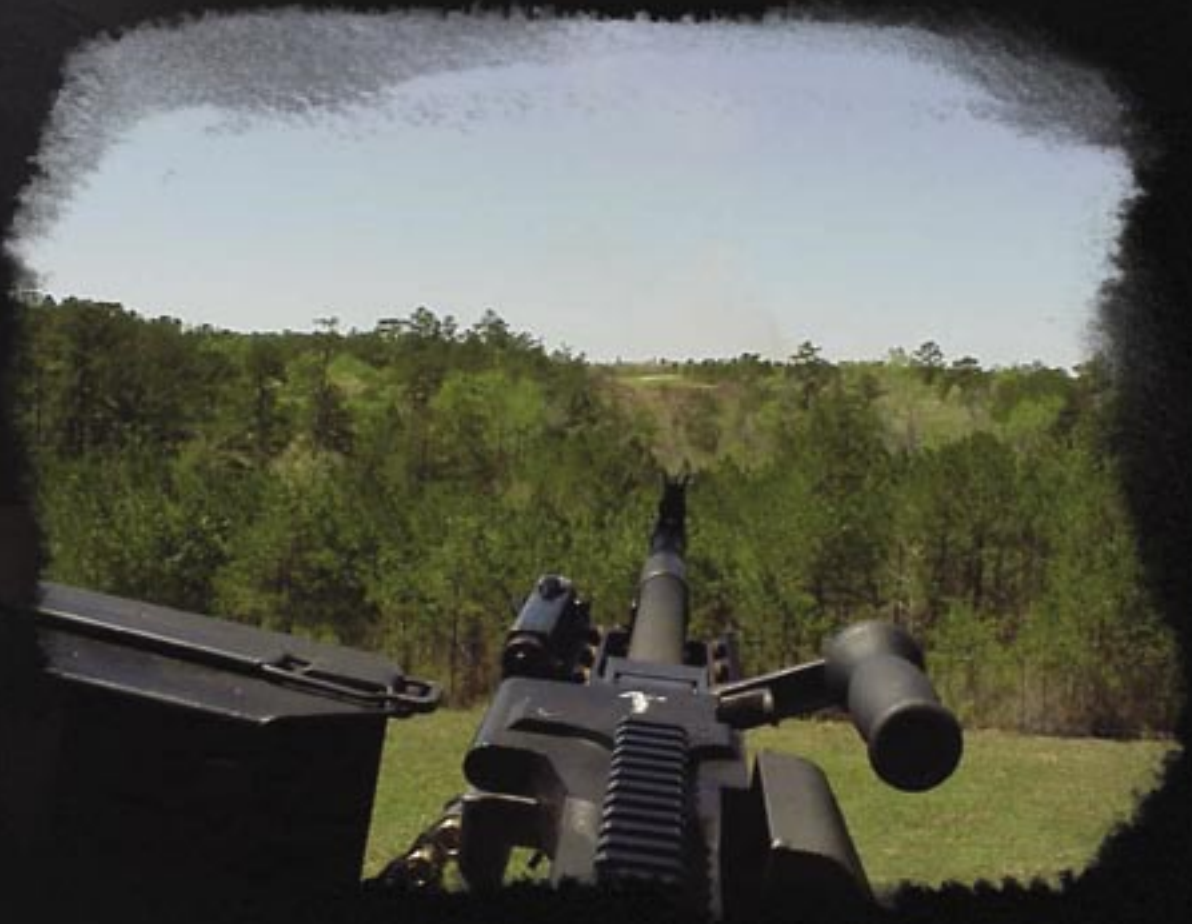
The M240H is a 7.62 mm belt-fed, gas-operated, air-cooled, fixed headspace weapon. Rate of fire is operator-selected and varies from 650 to 950 rounds per minute. Maximum effective range is 1,100 meters, with a maximum range of 3,725 meters. The M240H system weighs slightly more than its predecessor. The M240 family of machine guns has been cited as one of the most reliable machine gun systems in the world today.

With the support of the U.S. Army Aviation Technical Test Center (ATTC), flight testing was conducted at Molinelli Aerial Gunnery Range Complex at Fort Rucker, AL. Helicopter gunnery tables were completed in accordance with Field Manual 3-04.140, *Helicopter Gunnery*. The

weapon system was test flown aboard UH-60 and CH-47 aircraft in a variety of flight regimes and profiles including ground, hover, takeoff and landing, moving, and running fire.

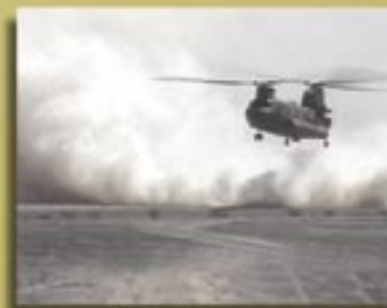
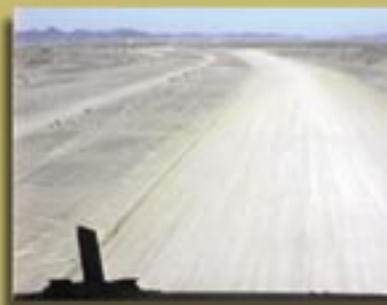
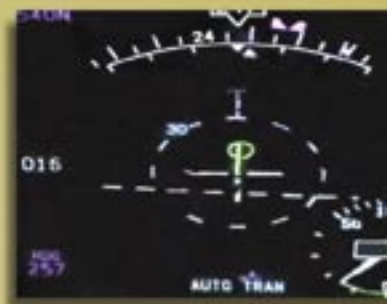
The real test of the system's attributes came during actual brownout landings at Yuma Proving Grounds (YPG), AZ. Using the Kofa Dust Course, noted for having brownout conditions most similar to both Iraq and Afghanistan, day and NVG brownout approaches were conducted. As shown in the sequence of photos, test cameras installed inside and outside the aircraft captured each approach. From outside the aircraft, the first set of images depicts the magnitude of the CH-47 in brownout conditions. Concurrently, the second set of images shows the view through the pilot's canopy.

This clearly illustrates the degradation in the visual cueing environment and lack of outside visual references to assist with descent rate, lateral drift, and aircraft attitude.

Finally, a camera placed over the pilot's shoulder captures the symbology on the MFD. As the aircraft descended through 15 feet AGL and began to encounter the dust cloud, the symbology continued to provide those critical elements necessary to retain situational awareness. As the aircraft decelerated, the system automatically scaled in velocity, providing better resolution to the aircrew. Then, monitoring heading, velocity, lateral drift, and rate of descent, the

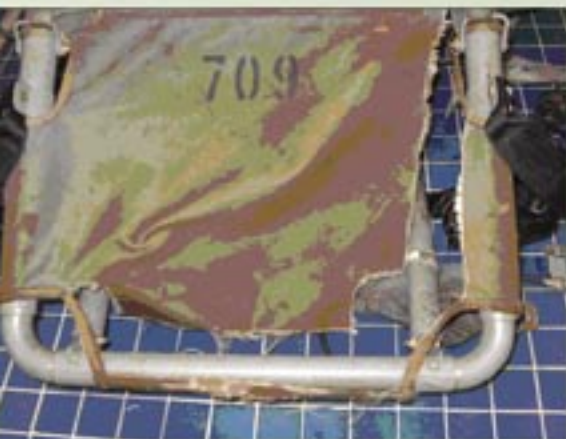
Photo 1. UH-60 passenger seat bottom failure

**T**he UH-60 design sought to guarantee the first truly crashworthy cabin seating for helicopters in the history of the industry. Now that the UH-60 has been in the field for more than two decades, perhaps it is time to review the effectiveness of its troop seating. During the January 2004 Aviation Safety Investment Strategy Team (ASIST) review of UH-60 accidents, it was noted by the U.S. Army Aeromedical Research Laboratory (USAARL) Aviation Life Support Equipment Retrieval Program (ALSERP) personnel that in a single aircraft that crashed, although there were no fatalities, 9 of the 12 troop seat pans in the aircraft experienced varying degrees of failure of the cloth portion of the troop seats. The most injurious trauma sustained was by a passenger who literally tore through the cloth seat pan cover (photo 1).

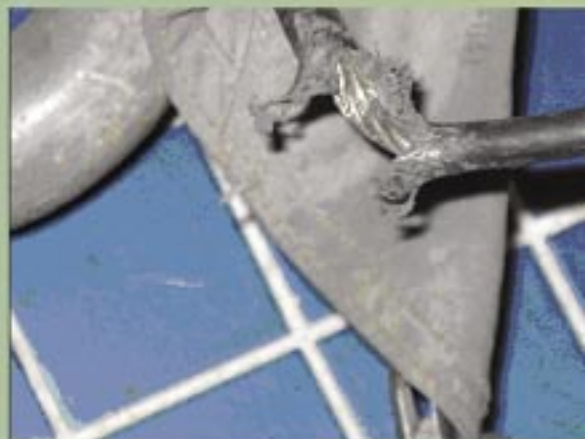
Photo 5. Permanent kinking of seat cable

In this same seat, all the cables complied with the policy on broken strands, although one of the cables (not included in the photo) had two broken strands. With regard to kinks, photo 5 shows a cable with an area of kinking that was unsatisfactory and should have been replaced.

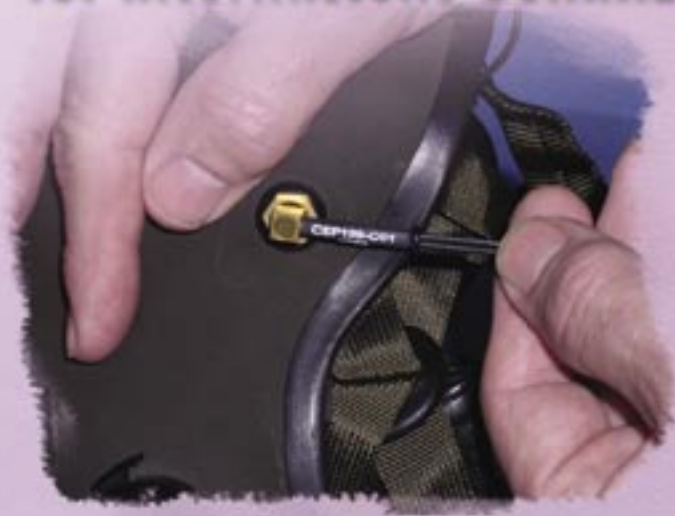
# FIELD "FIX" for Intermittent Communication Signals in the CEP

The communications earplug (CEP) is a device that is used to improve hearing protection and speech communications in the high noise environments found in helicopters. It includes miniature transducers that reproduce speech signals from the aircraft intercommunication system (ICS). The foam tip acts as a hearing protector, providing 30dB of suppression when properly inserted in the ear canal. It contains a pathway for communication sound signals to travel from the transducer to the ear, thus permitting quality sound at safe levels to reach the user.
